PARK RANGE CONSTRUCTION NEWS

ISSUE 04, December 2012 303.781.8936 ParkRangeConstruction.com 2755 South Raritan Street, Englewood, CO 80110

Structural Floor & Foundation Wall Repair in Littleton

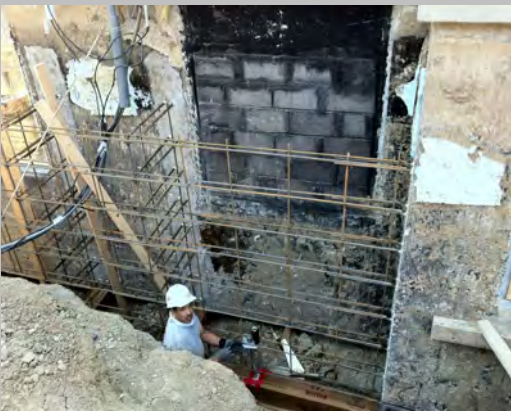
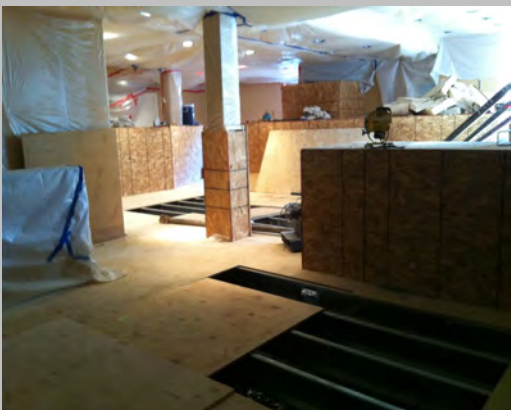
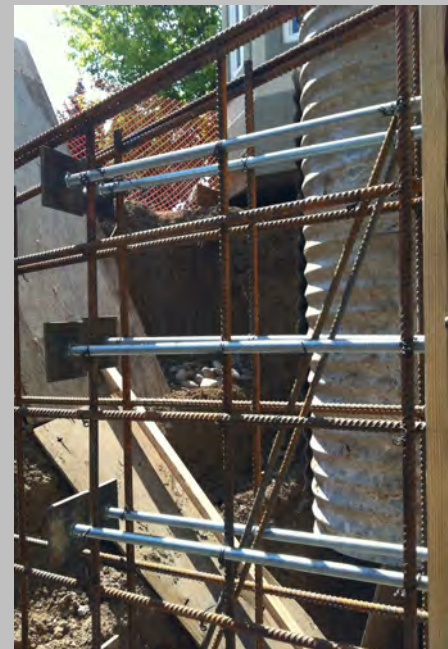
A Littleton home was experiencing buckling foundation walls and structural floors due to expansive soil pressures imposed on the structure. Park Range Construction was hired to build counterfort walls and to install micropiles, realign the foundation walls and install perimeter drains. The soils surrounding the foundation were replaced with non-expansive soils.

Care was taken to provide wall and ceiling containment not only for the furnishings and kitchen countertops not removed from the fully-finished basement during construction, but also for a large marine coral fish tank the homeowner needed to protect to assure her fragile live coral were safe from exposure to the dust and debris during construction.

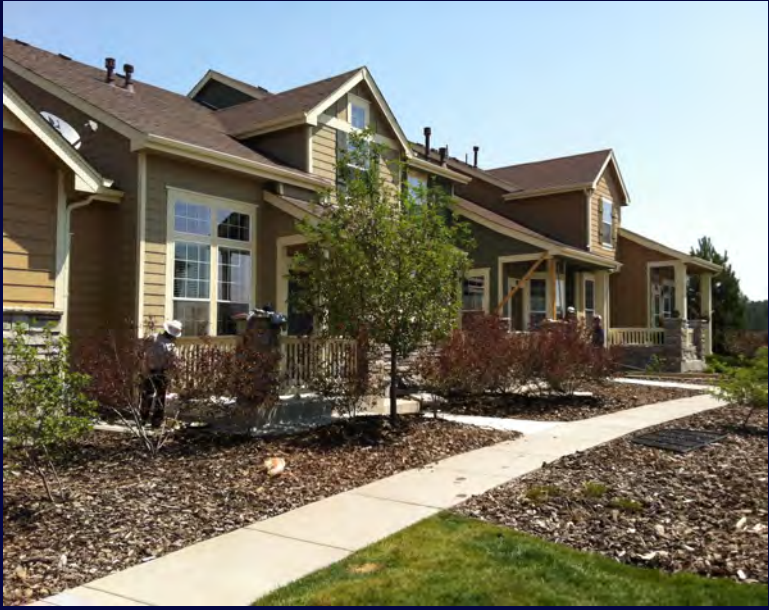
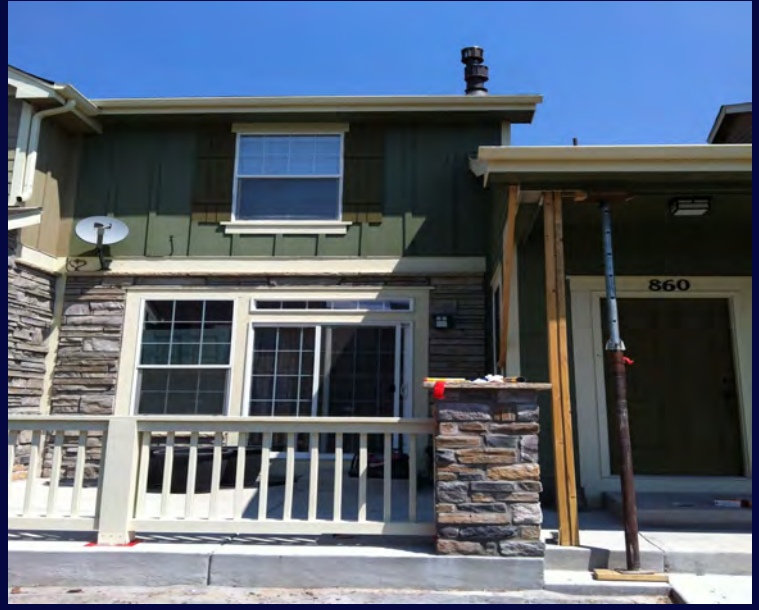
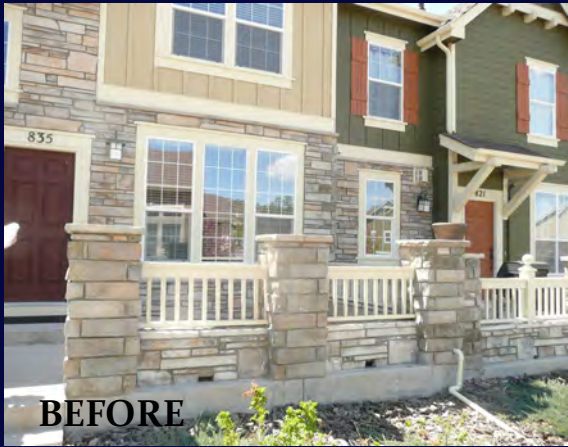
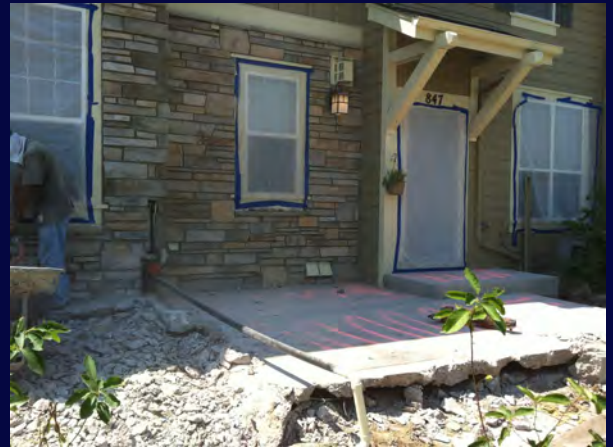
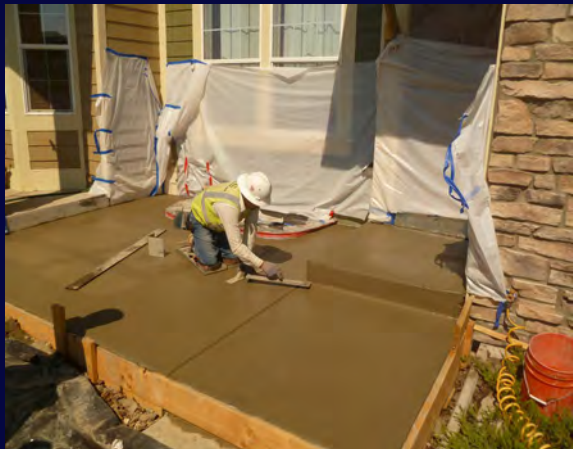
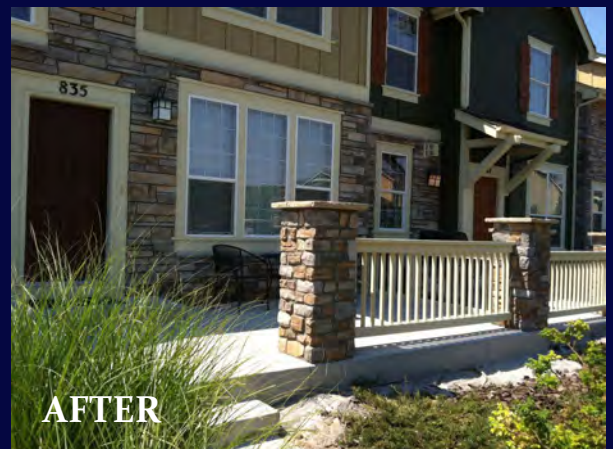
The HOA community had numerous issues with spalled and cracked concrete porches. The railings and columns originally designed did not allow for water to drain and the wooden columns were rotting. See Wood/Stone/Veneer Before photo at upper left. This community-wide project involved concrete demolition, pipe re-direction, railing and column re-design, rail to siding connections, rail abutment to stone walls, new wood columns with stone wrapping, flashing of

the building at the porch to wall connections, new concrete pours, landscaping and mulching.

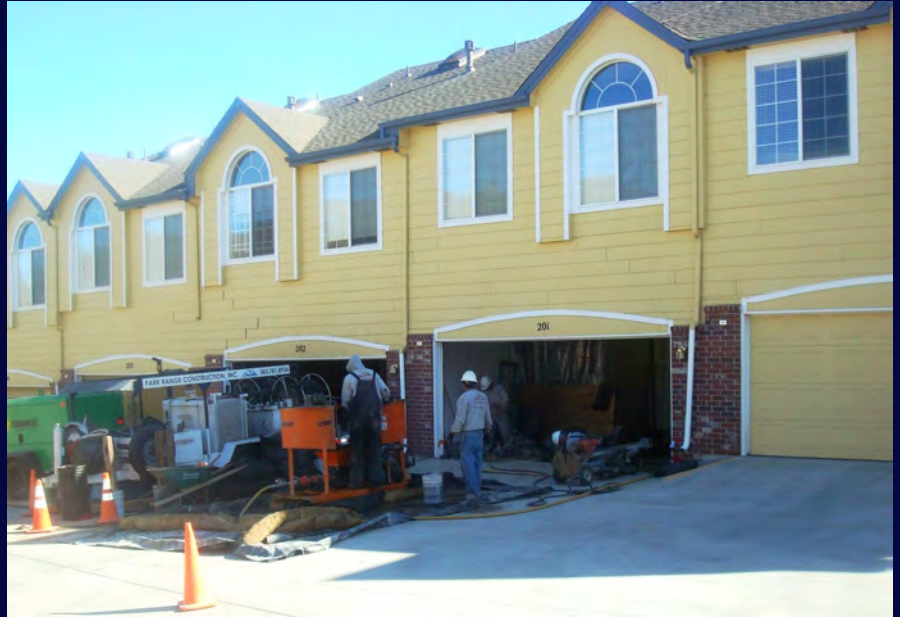
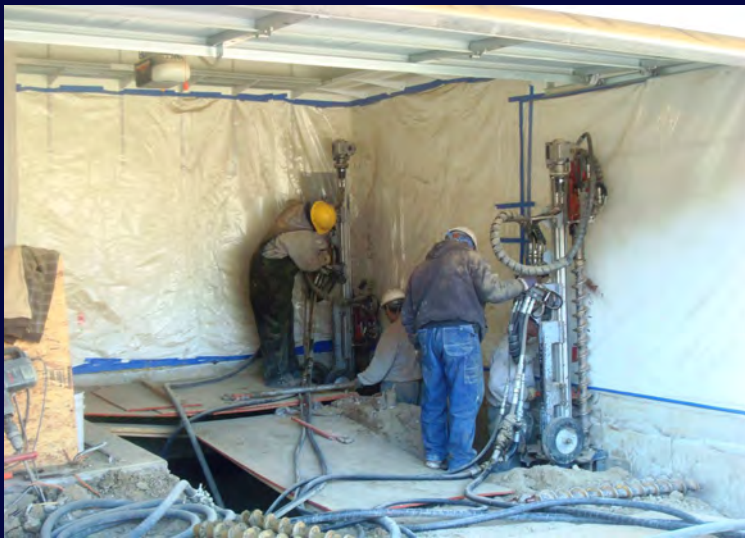
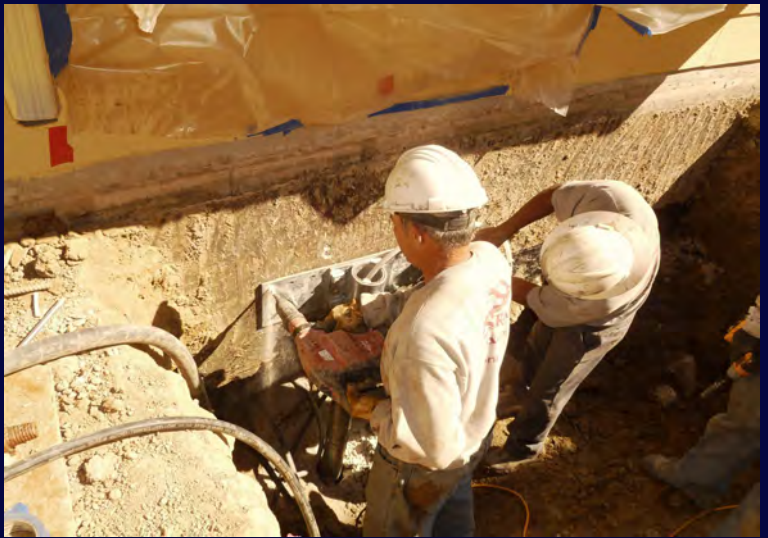
Front porch repairs included removing and replacing the brick columns, privacy walls, 6x6 post columns, installing micropiles to a depth of 45' including underpinning brackets to attach them to the foundation, revoiding of the foundation along the length of the porch walls as well as replacement of concrete porch slabs.

Crawlspace repairs included 4" diameter micropiles with underpinning brackets, a new perimeter drain system including a sump pit and pump with a connection to the town sewer line. Garage repairs involved installing 4" micropiles and 2' long dowels, slab and subgrade replacement.

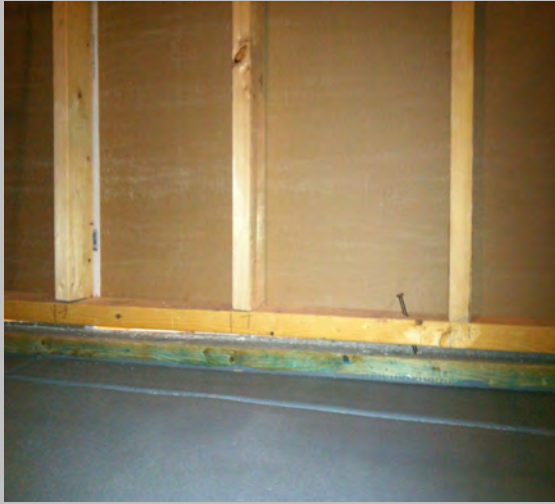
A Larkspur resident called Park Range Construction to find out why his finished basement walls were cracking. When the walls were opened up, it was obvious that the expansive Colorado soils were pushing up on the sill plates, in essence pushing the walls up and the non-flexible drywall cracked. To remedy this problem Park Range Construction made the interior, non-load bearing walls float. Creating a 2" minimum void space and using 60 P Nails allows the walls to move up and down 2" with the swelling and shrinking soils.

Care was also taken to ensure that when the walls floated that the piping was given 2" notches within which to sit as well as rubber compression boots so they would not be affected by the movement. The drywall was repaired and painted to match the existing walls.

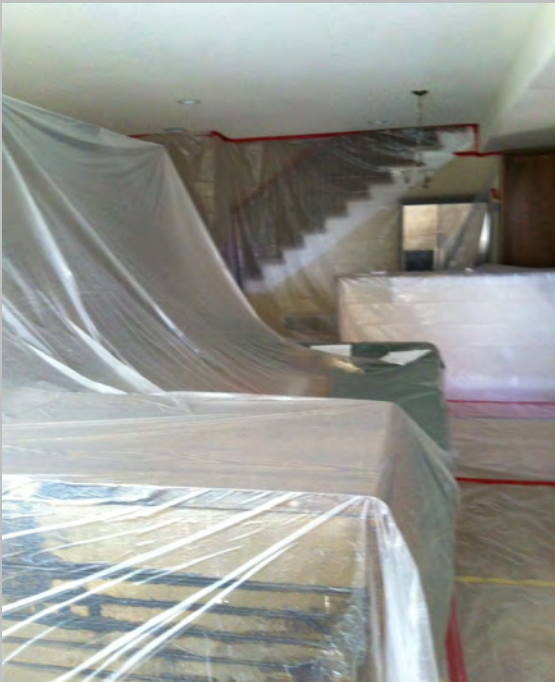
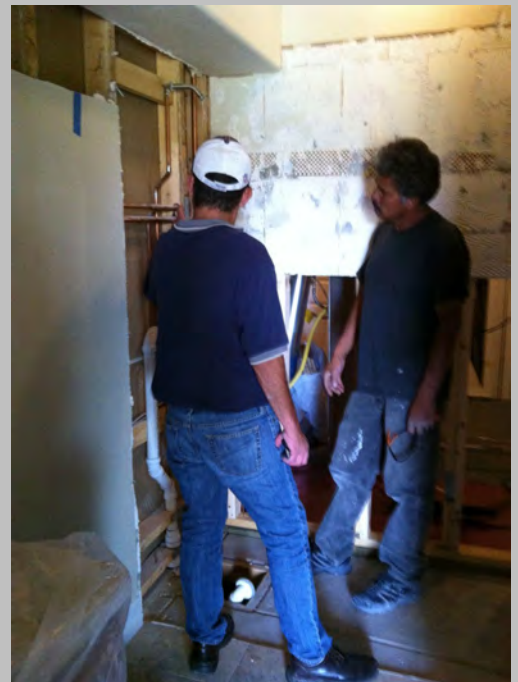
Park Range provided floor to ceiling containment to separate the finished basement from the upstairs living space during construction.

As an exterior solution to the swelling and shrinking soil issues, a partial perimeter drain was installed around the front porch. The garage slab-on-grade floor was replaced as were the front and rear patios.
