PARK RANGE CONSTRUCTION NEWS

ISSUE 03, May 2012 303.781.8936 ParkRangeConstruction.com 2755 South Raritan Street, Englewood, CO 80110

Helical Pile Installation at Power Plant Sub-Station

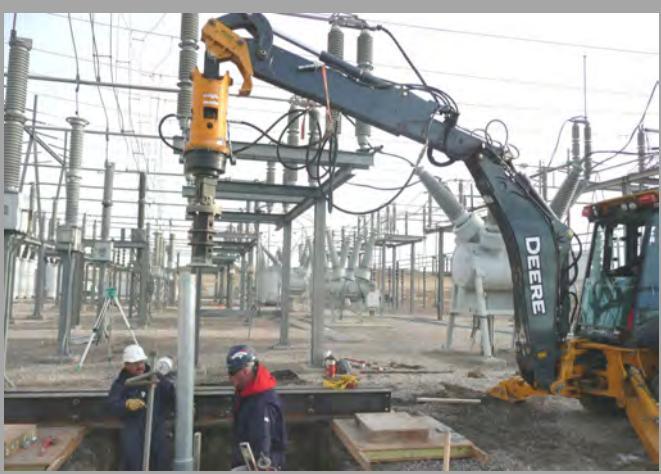
Park Range Construction was awarded the contract to install 250 Magnum galvanized 6.50° O.D. x .280" wall thickness tubular piles with a single .875" x 24" helice plate and 10"x10" pier caps welded to the shafts. Piles were installed to support foundations for a new sub-station at a power plant.

The soils were soft and sandy in the upper 15 feet. The conditions were ideal for helical piles. The $6\frac{1}{2}$ helical pile met the lateral capacity requirements of the engineer and torqued to the required capacity at 18-24 lf.

Park Range performed six proof tests in tension. The tests were measured optically and by micro dial gauges. The proof tests were loaded to 22.55 kips which was 150% of the design load. The site was very congested, drilling next to and under transformers. (Continued on Page 4)

Park Range Construction performed both compression and tension proof and verification load tests on two non-production sacrificial helical piers installed per ASTM D₃689 and ASTM D₁₁₄₃ standards. The compression test consisted of a steel load frame; which the main reaction beam is a double 12x26 x 15' long steel beam bearing onto cross beams. All built up beam sections were welded together with $\frac{1}{2}$ " thick steel plates with space for the "all-tread" to go through and double $\frac{1}{4}$ " web stiffeners at all point load locations.

Cross beams were made of double MC 18x45.8 steel C-channels back-to-back that bore onto four reaction piles. The reaction piles were tubular piers with multiple helices installed to accommodate the loading criteria. All connections used appropriate tie-back transitions and caps specifically designed for each application.

The tension test had a double 12x26x 15' long steel load frame bearing onto 4'x4' built up cribbage. Four additional field verification tests were performed on production piles as specified in the construction documents.

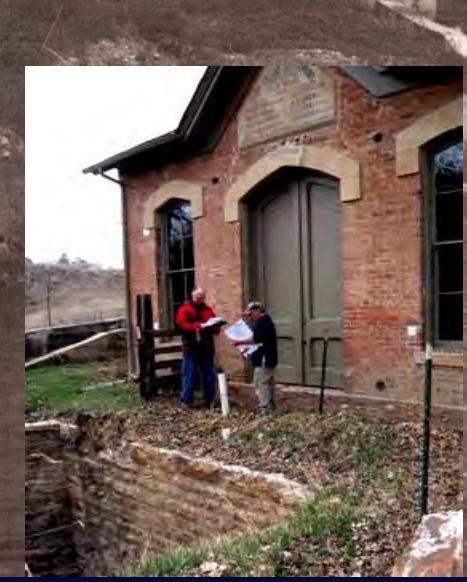
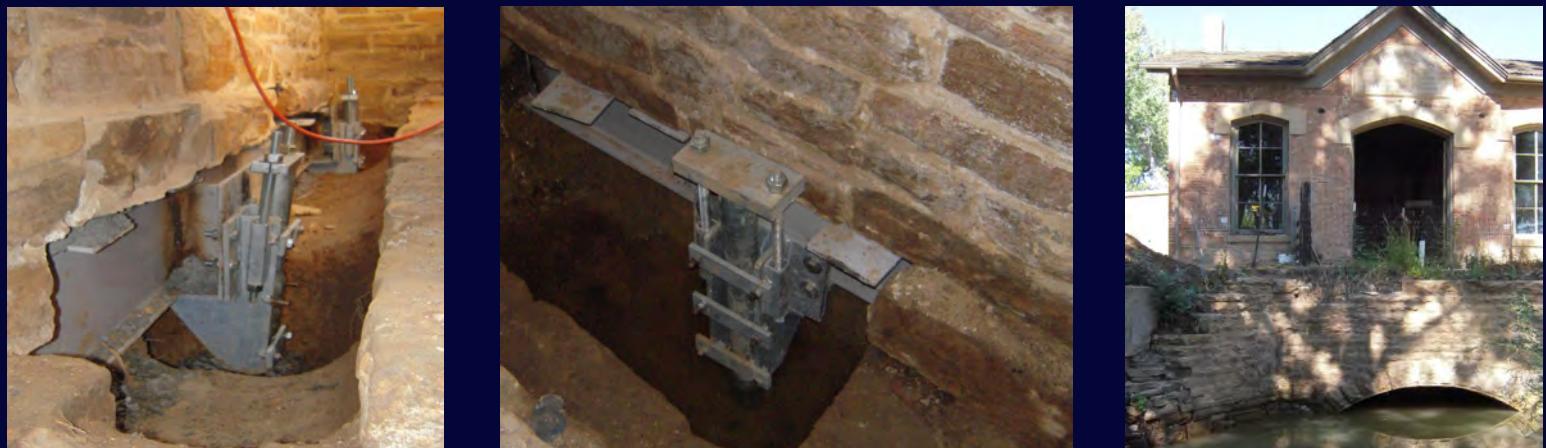
Historic Water Works Renovation

The City of Ft. Collins constructed a water delivery system to improve everyday life in 1882. This provided water to fight fires and the ability to pump clean drinking water to the citizens. Preservation of this historical site required a new foundation support system. Park Range Construction was contracted to install ECP Galvanized 2 7/8" tubular piers to underpin and re-level the foundation. Piers were installed with underpinning brackets attached to W 10x26 ASTM galvanized I-Beams with face plates. The piers and I-Beams were placed under the existing footings to spread the load along the old stone block foundation and stabilize the structure. - Engineered by AE Design.

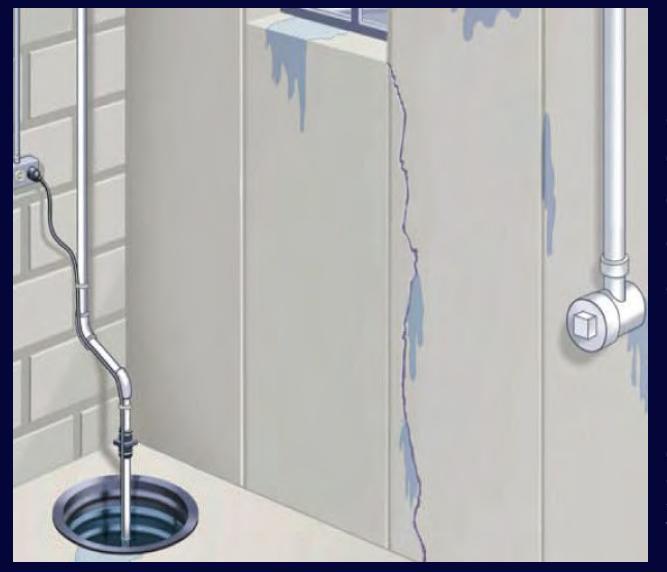
PERIMETER DRAINS

Perimeter drains are a way to remove water that may accumulate around and under your foundation as well as control hydrostatic pressure. The key to the effectiveness of the system is proper installation and proper discharge of water through the sump pump and pump extension away from the foundation.
